# Analysis of white strip defects in the galvanized coating surface of hot -dip galvanized DP steel

CHEN Guang<sup>1</sup>, ZHU Min<sup>1</sup> and MAO Weichen<sup>2</sup>

**Abstract:** The microstructure and characteristics of two types of white stripe defects in hot -dip galvanized DP steel were studied, and the relevant processes were analyzed and discussed. The results show that both types of white strip defects originate from the surface defects of the substrate before galvanizing, and one originates from iron scale of finishing roller, with its microstructure characterized by characteristic elements Mo, V, Cr, Ni, etc; Another type originates from microcracks in the casting slab, whose microscopic characteristics are mainly secondary oxides. Based on the above analysis, the paper clarifies the impact of hot rolling and slab casting processes on white strip defects.

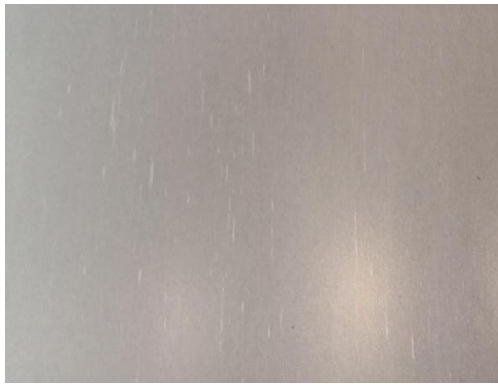
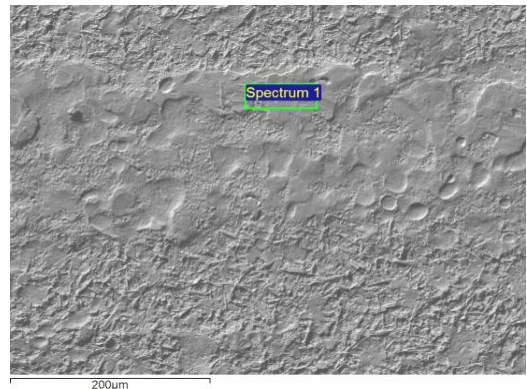
Fig.1 Macroscopic morphology of 1 # defect (small short strip)

We found two types of white strip defects on the surface of hot-dip galvanized dual phase steel. One is a small short strip, and the other is a slender strip (hereinafter referred to as 1 # defect and 2 # defect respectively). Both types of defects exhibit white stripe morphology macroscopically, but their distribution is different. 1 # Defects are densely distributed on the lower surface of the strip steel, the stripe width is 0.1-0.3mm, with length of about 20-30mm, along the rolling direction of the strip steel (Figure 1). 2 # Defects defects are mainly distributed on the upper surface of the strip steel. appearing as white slender strips with a width of 0.1-0.4mm and a length of about 20-60mm, also along the rolling direction of the strip steel (Figure 2). Strip steel with these two types of white strip defects cannot be shipped as qualified products to consumers.

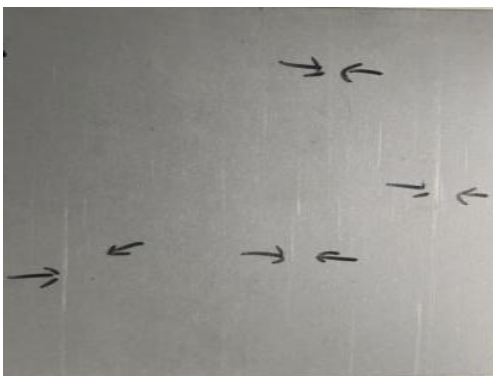
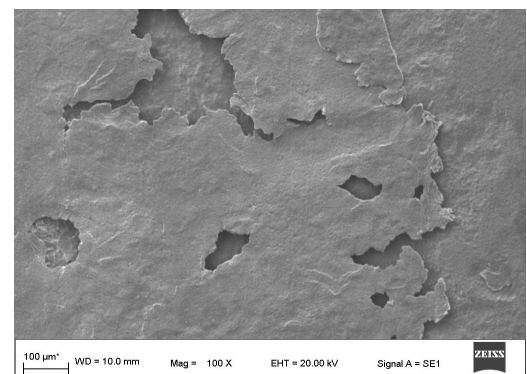
Fig.2 Macroscopic morphology of 2 # defect(slender strip)

The galvanized coating was dissolved from the defect area and surface polishing treatment was performed. SEM morphology observation and energy spectrum analysis were performed. No hot rolling roller components such as Si, Mo, V, Cr, Ni were found, nor were any steelmaking protective slag components found. It can be seen the causes of defect 2 # and defect 1 # are significantly different.
