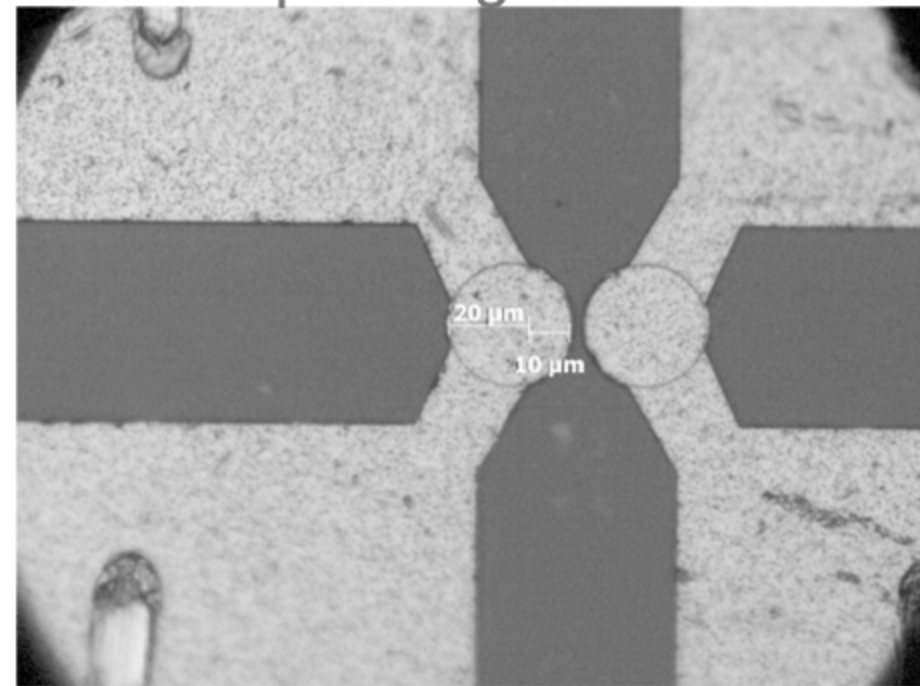
Fig 1) Left: Optical microscope image of the analysed junction. Moving to the right of the figure: The reconstructed intensity image of the HEXRR-tomo obtained by combining different HEXRR images and different positions on the sample. Lower angles reveal the morphological imperfections at the junction borders.
