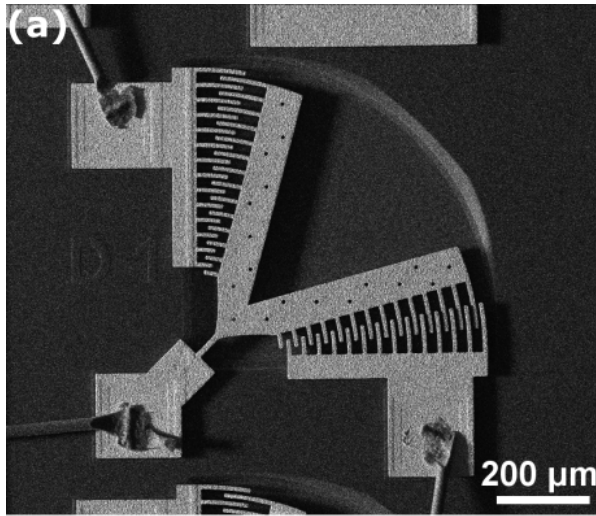
Figure 1 - (a) Microresonator ready for in-situ SEM fatigue testing; (b) Inclined SEM image after high cycle fatigue test showing extrusions and a crack at the sidewall of the microbeam; (c) FIB cross-section of the microbeam demonstrating voids in the proximity of the crack; (d) Fracture surface of microbeam after low cycle fatigue test
