## Supporting Figures

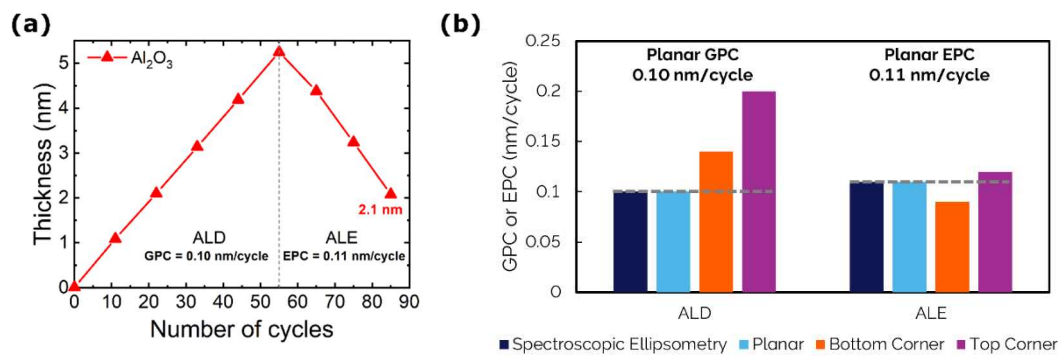
Figure 1: (a) In-situ film thickness measurement of  $\text{Al}_2\text{O}_3$  during 55 cycles of ALD ( $\text{O}_2$  plasma + TMA) followed by 30 cycles of ALE ( $\text{SF}_6:\text{H}_2$  plasma + TMA). (b) Comparison of the different GPC and EPC values extracted from the in-situ spectroscopic ellipsometry and TEM analysis. GPC is higher in corners, while the EPC changes very little.

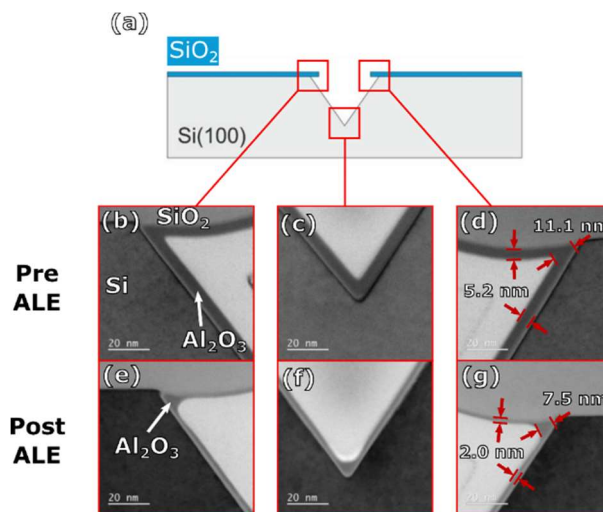
Figure 2: (a) V-shaped trench structure used for TEM analysis. The overhanging  $\text{SiO}_2$  mask is left in place to provide additional corners in the structure. (b,c,d) TEM images of the structure pre-ALE, showing a 5 nm film in the planar regions and thicker film in the corner. (e,f,g) Post 30 ALE cycles the film is thinned down, however a thicker film is maintained in the corners.
