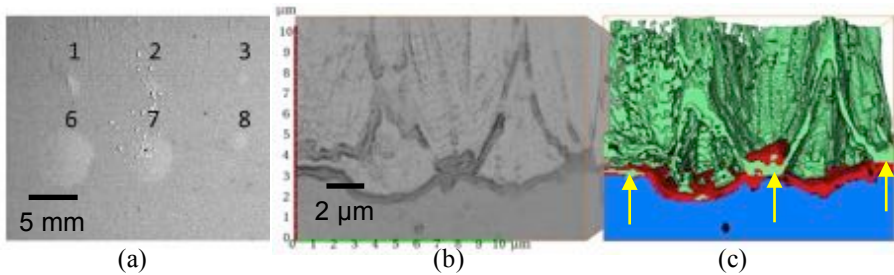
Fig. 1 Specimen after LASAT (a) top-view evidencing the contrast induced by debonding (b) FIB BSE and (c) segmented images : bond-coat in blue, TGO in red, gaps between columns and crack in green and yellow arrows indicating micro-cracks within, below and above the oxide layer [4]

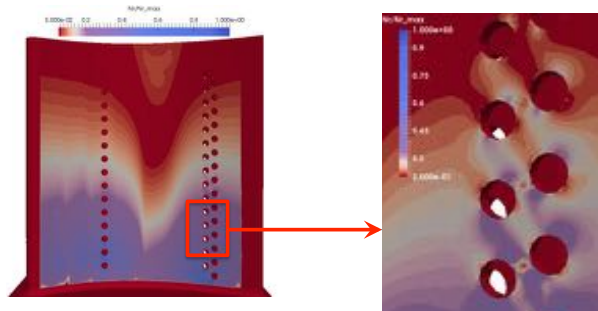
Fig. 2 Lifetime modeling of a turbine blade (courtesy of B. Marchand)
