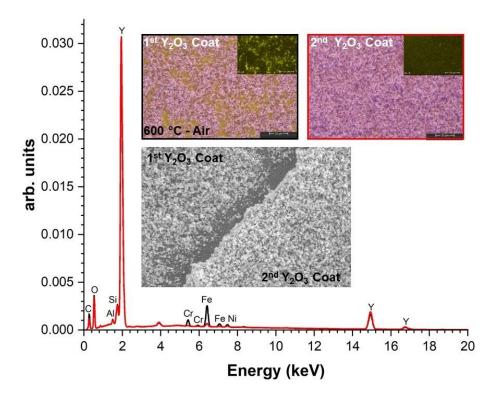
**Figure 1**: SEM and EDS of spray coated  $Y_2O_3$  on SS304 coupons at 500x magnification. Inset) 1<sup>st</sup> coat of  $Y_2O_3$  after thermal annealing in air at 600 °C (black border) has patches of exposed SS304. The 2<sup>nd</sup>  $Y_2O_3$  coat fills in patches (red border), and the attenuation of Cr, Fe, and Ni peaks appear on the EDS spectrum.
