> Scratch Test on DLC coating

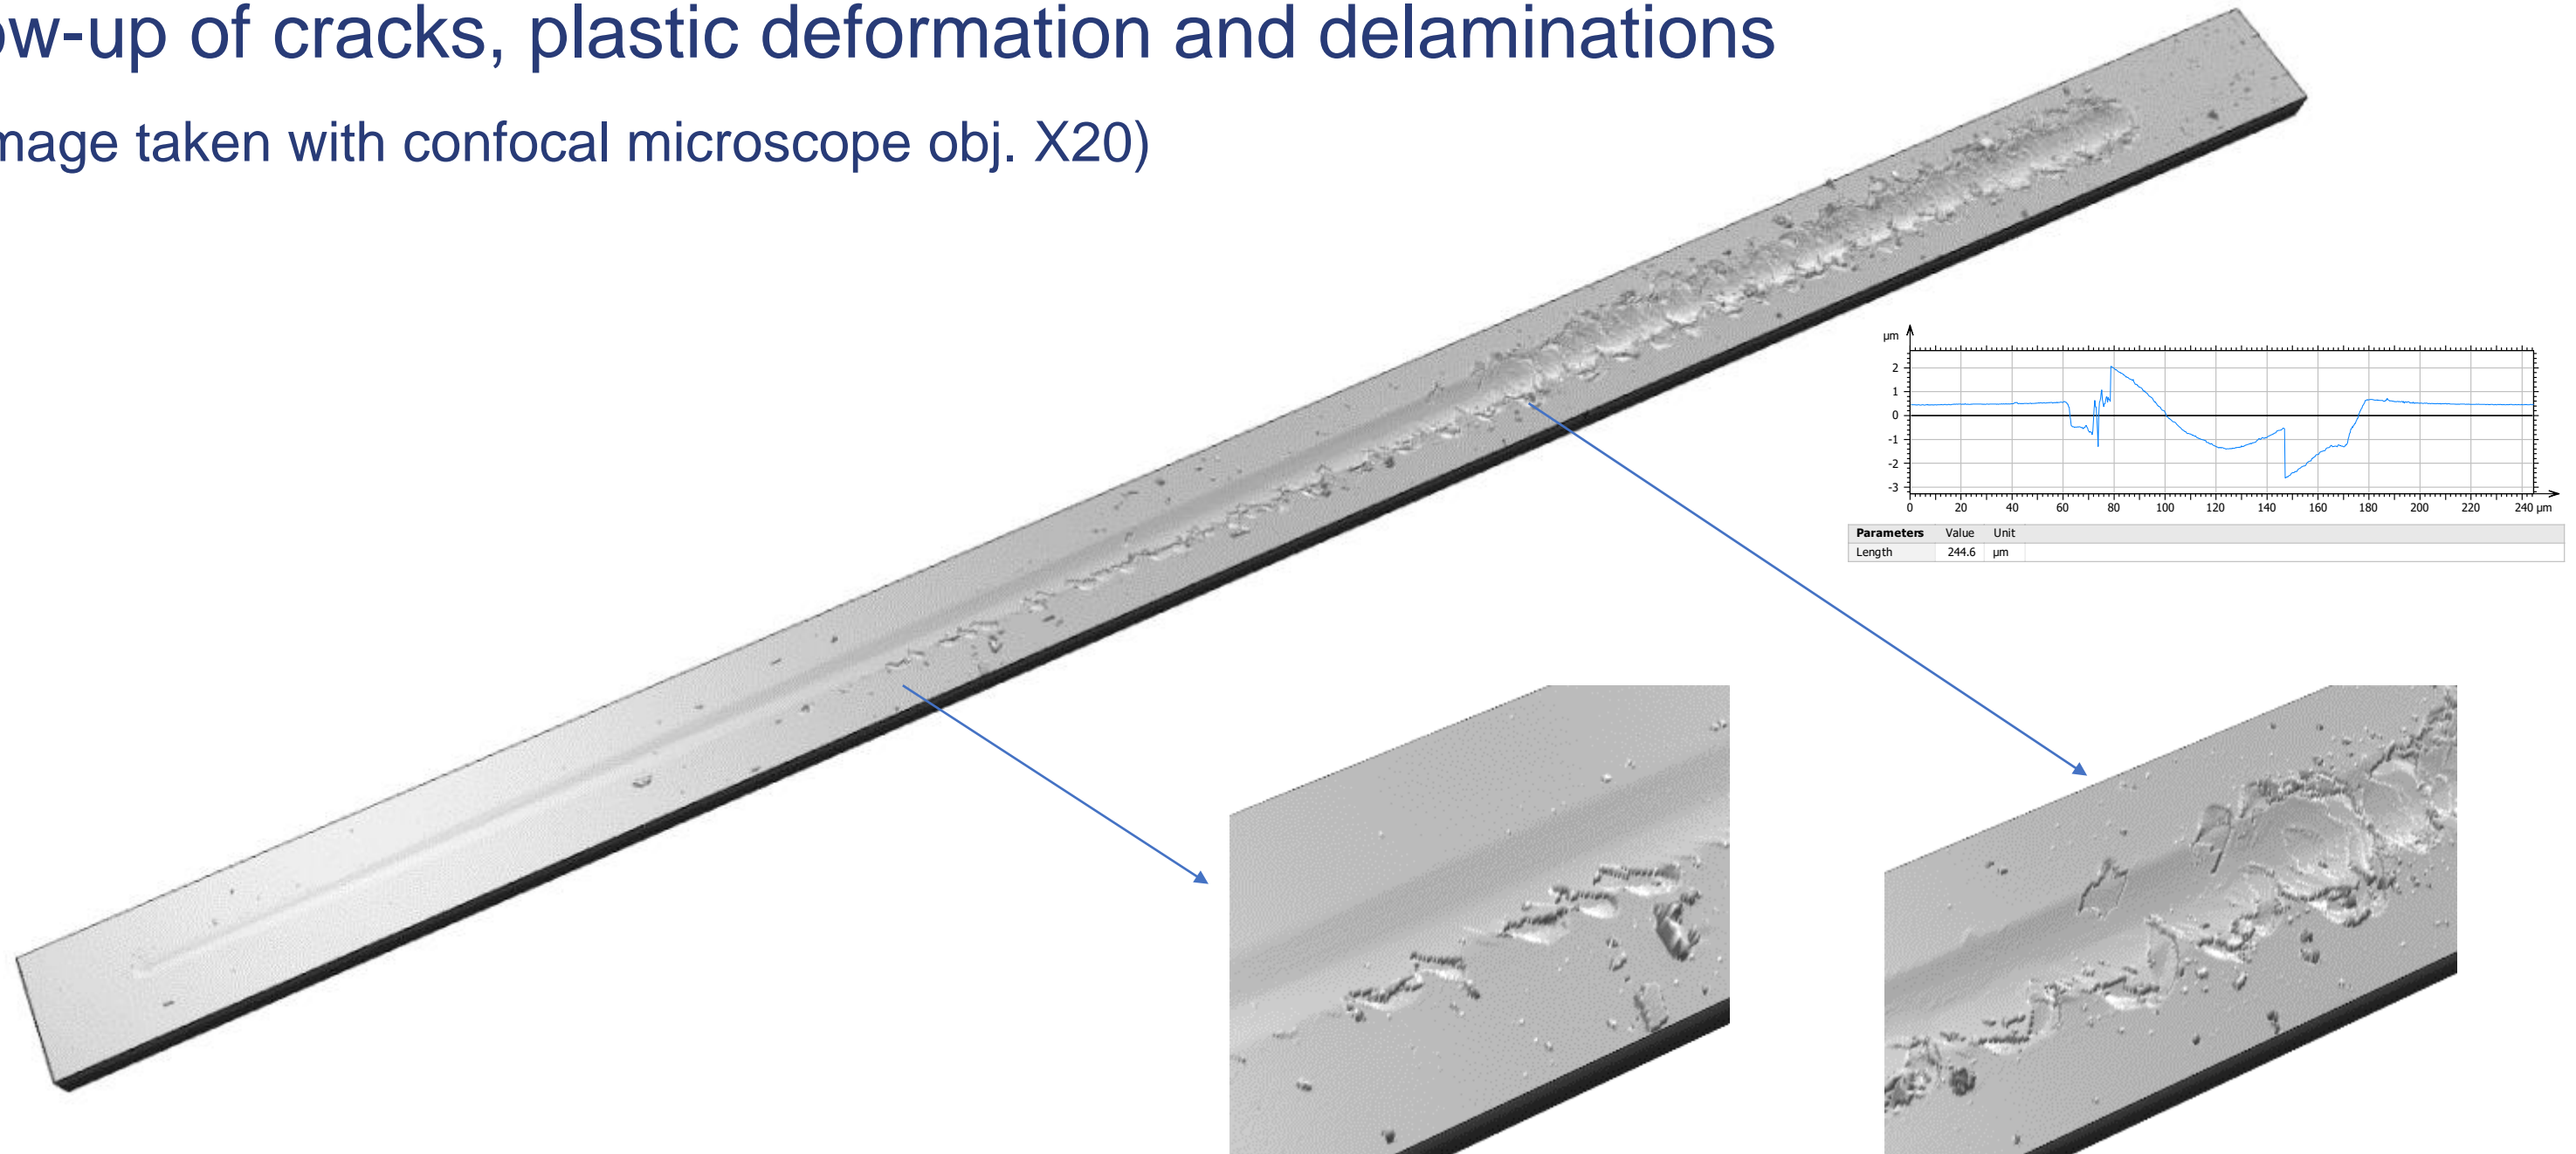
- Follow-up of cracks, plastic deformation and delaminations
(image taken with confocal microscope obj. X20)
